**Subject: Field Oversight Summary No. 2
Final Remedial Design Activities
Blackwell Forest Preserve Landfill, DuPage County, Illinois
Contract No. 68-W8-0084, Work Assignment No. 84-5P6Y**

**FIELD OVERSIGHT SUMMARY NO. 2
FINAL REMEDIAL DESIGN ACTIVITIES
BLACKWELL FOREST PRESERVE LANDFILL
DUPAGE COUNTY, ILLINOIS**

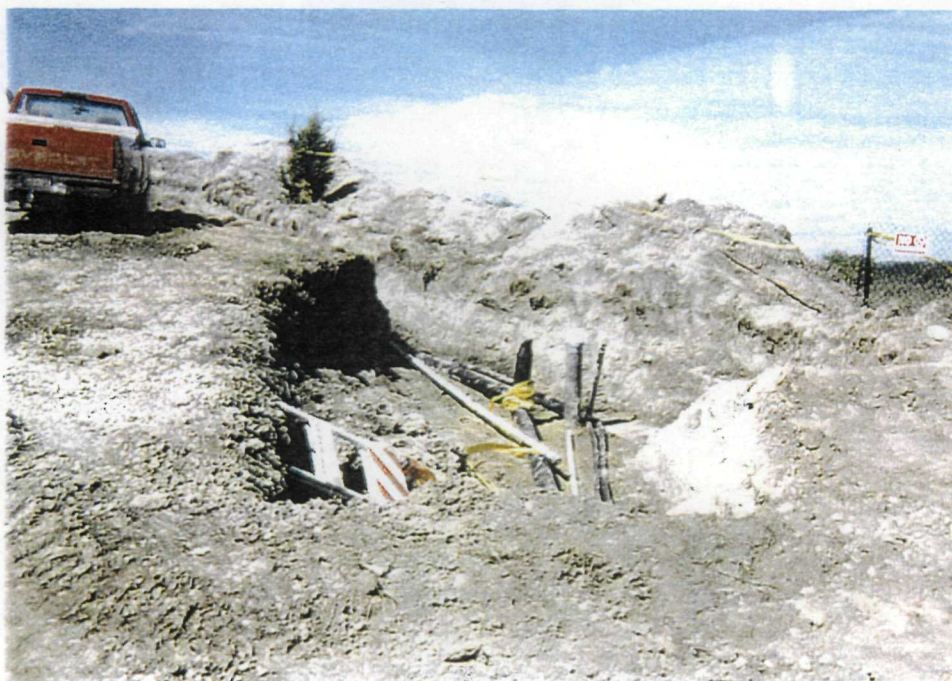
Photograph No. 6

Description: LCS trench at EW-05; EW-05 casing is gray pipe with white top

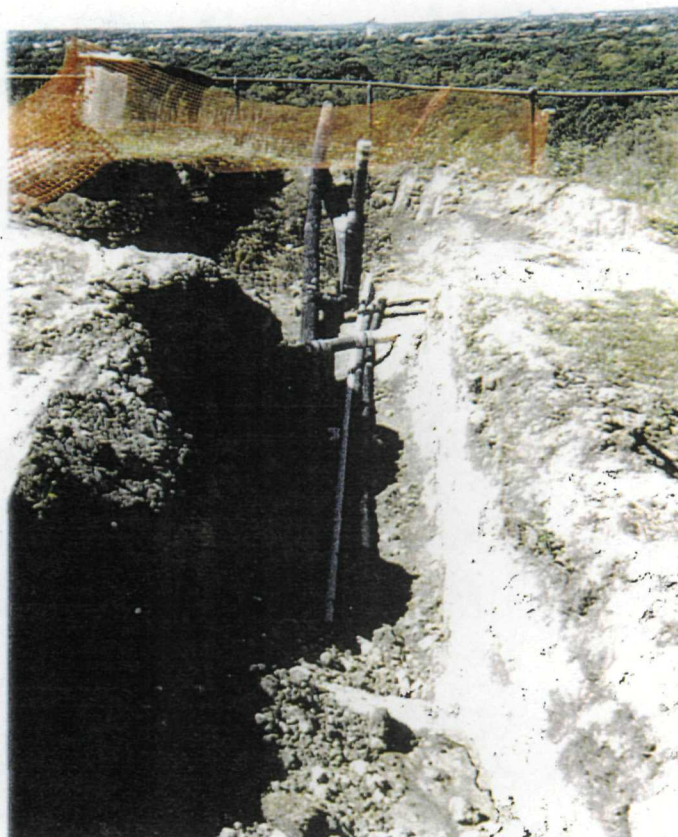
Photograph No. 10

Description: Close-up of LCS trench and EW-04 shown in Photograph No. 9

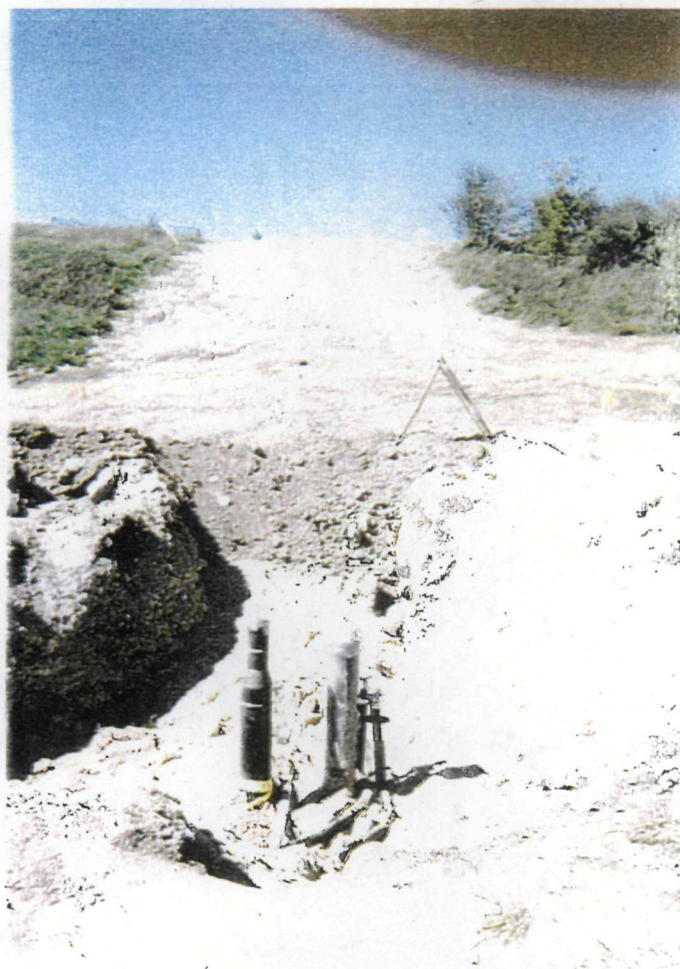
Photograph No. 21

Description: EW-06 (gray pipe with white cap); leachate trench in background extended to EW-05

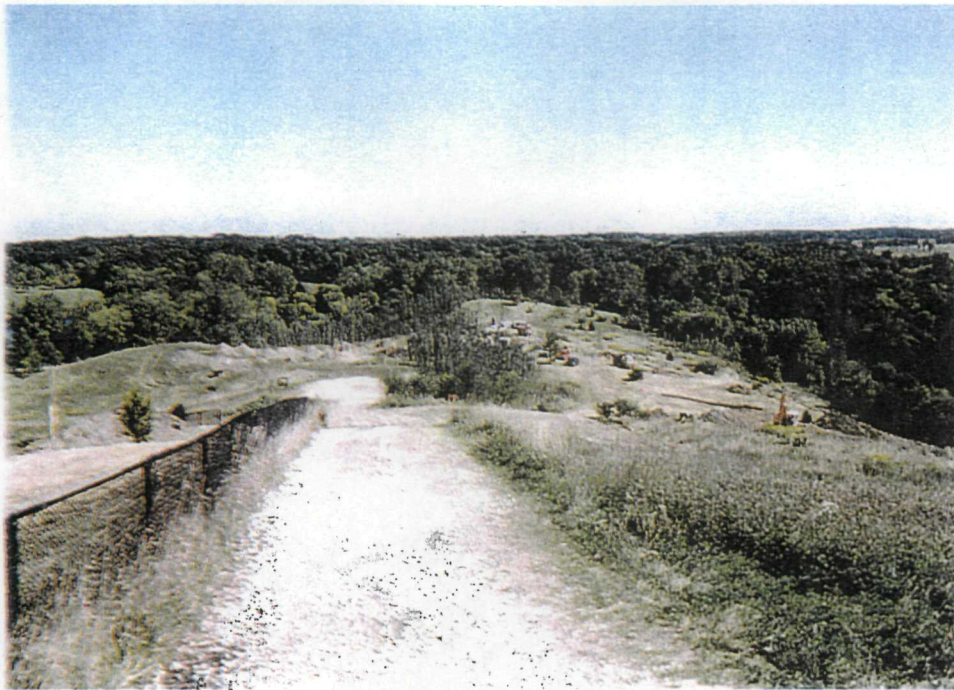
Photograph No. 22

Description: Overview of work performed on east side of landfill; activity on this date was between EW-07 and EW-08 in left-center of photograph)

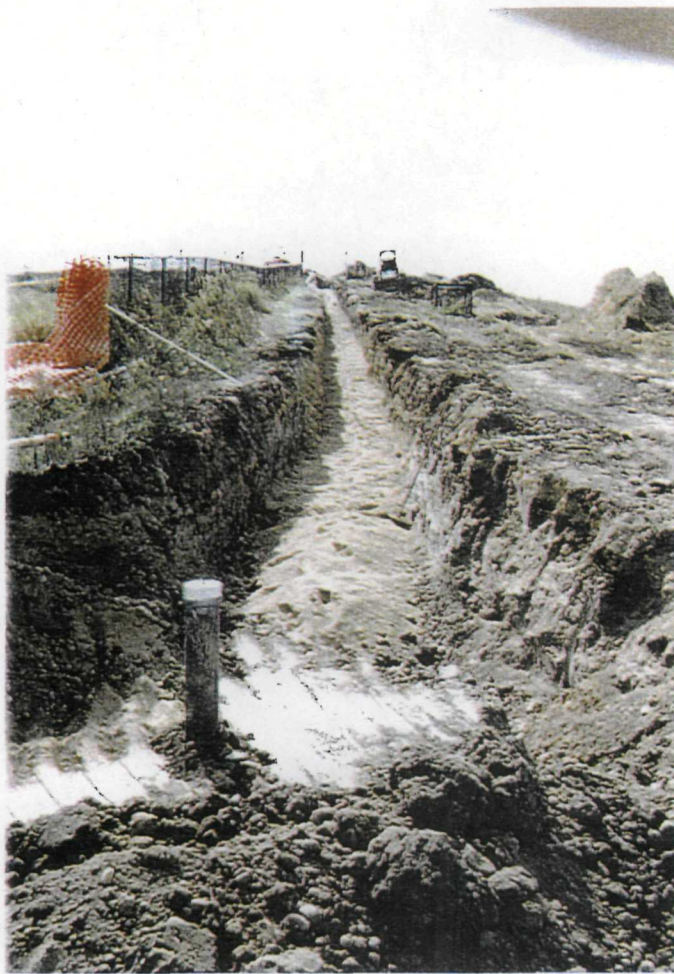
Photograph No. 2

Description: Close-up of LCS trench excavation on north slope of landfill; bottom layer of sand backfill had been placed in trench; EW-02 in foreground

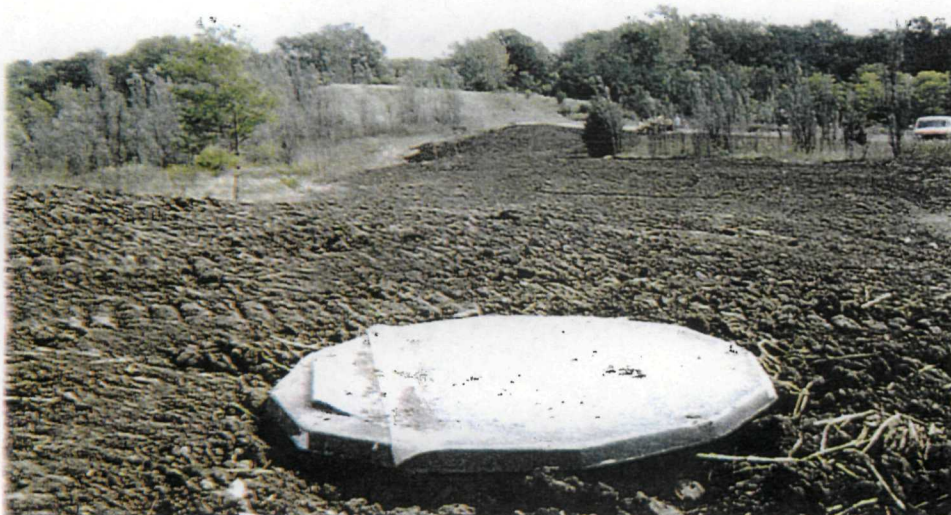
Photograph No. 7
 Orientation: East
 Description: Topsoil being placed on east slope of landfill after LCS trenches and extraction well vaults had been installed

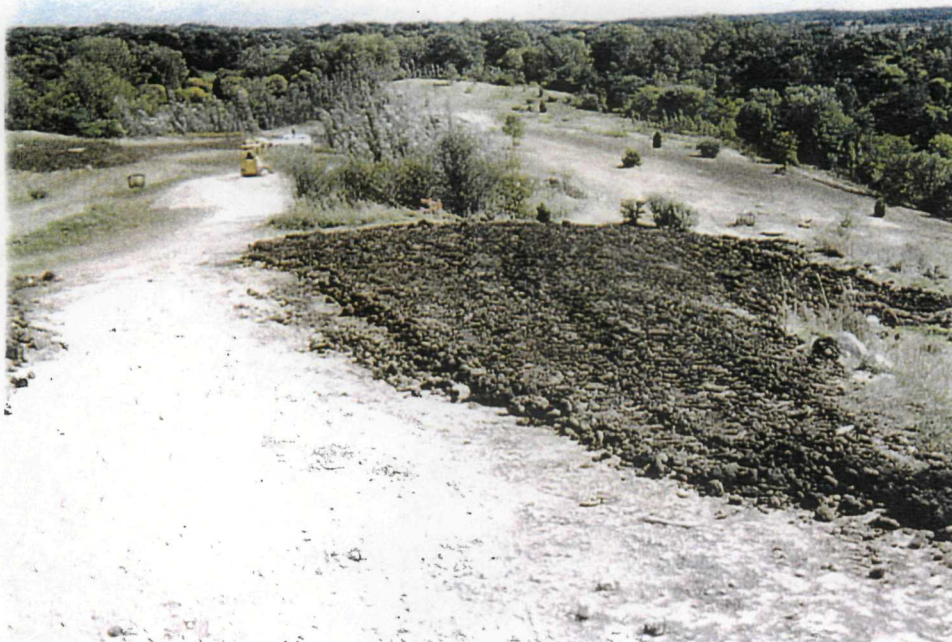
Photograph No. 8

Description: Topsoil spread between EW-07 (foreground) and EW-08 (background)

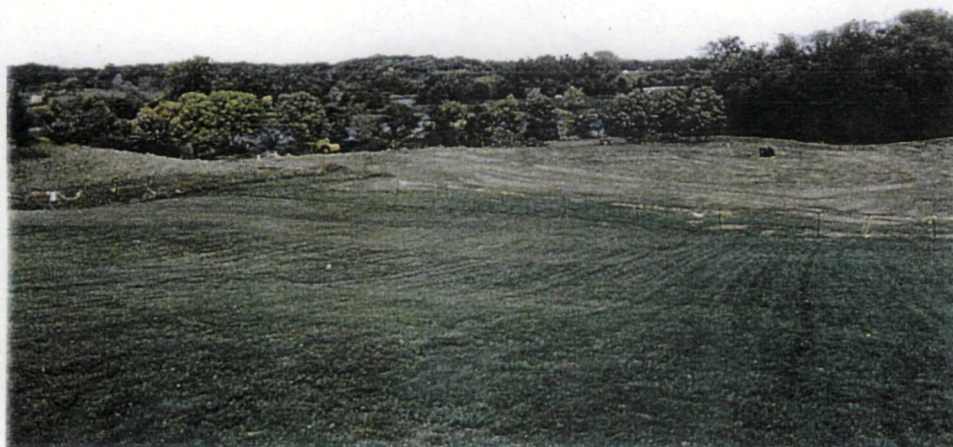
Photograph No. 9

Description: Stockpile of topsoil on north side of Area 3 used to cover east slope of landfill

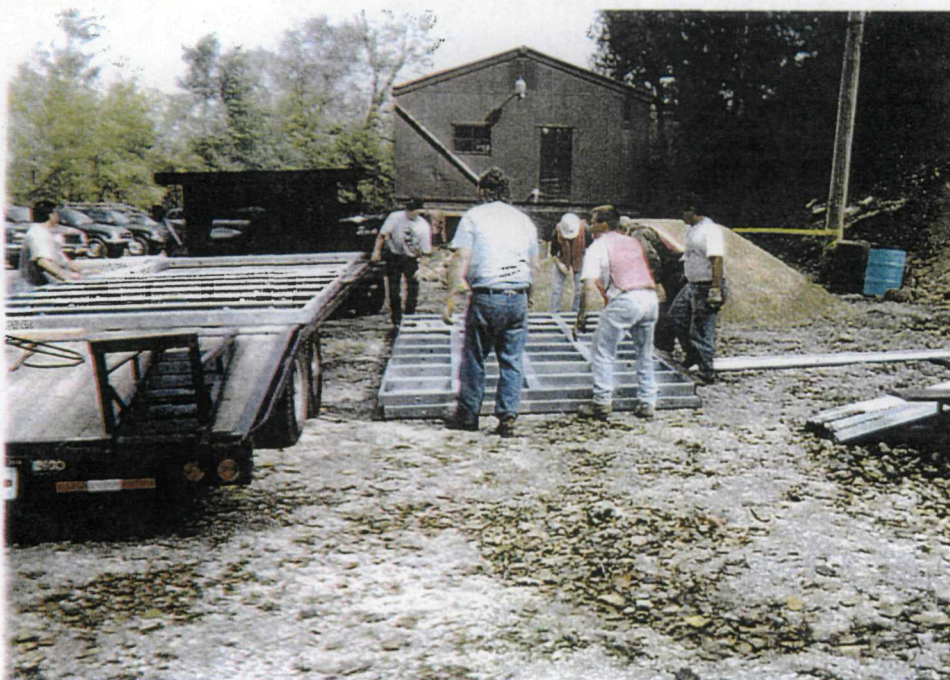
Photograph No. 12

Description: Components of compressor and control building being brought to site

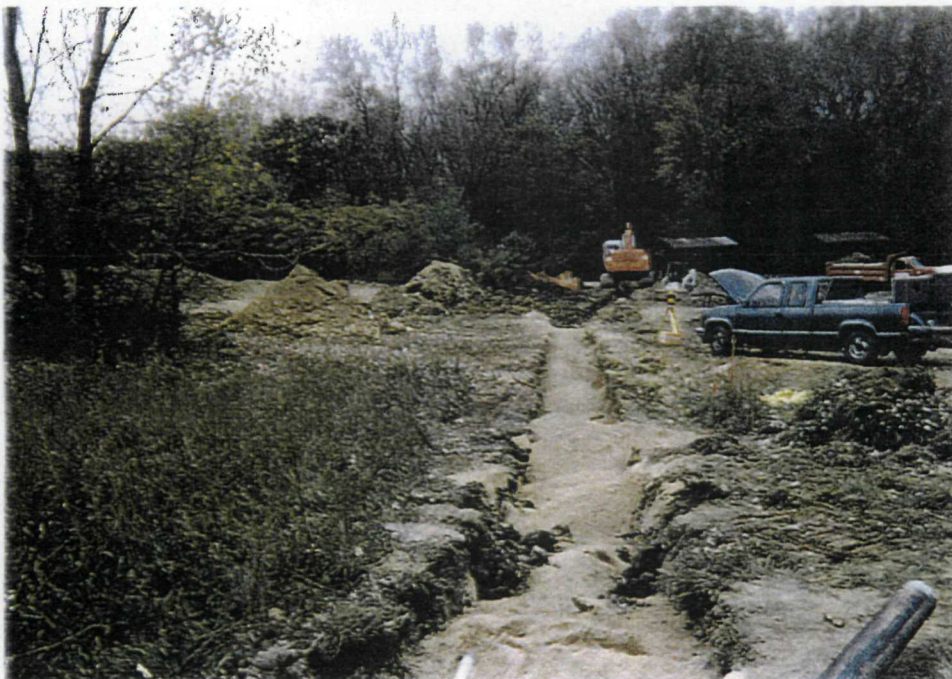
Photograph No. 16

Description: LCS trench excavation near manhole MH-3; portion of trench (foreground) had been backfilled with bottom layer of sand

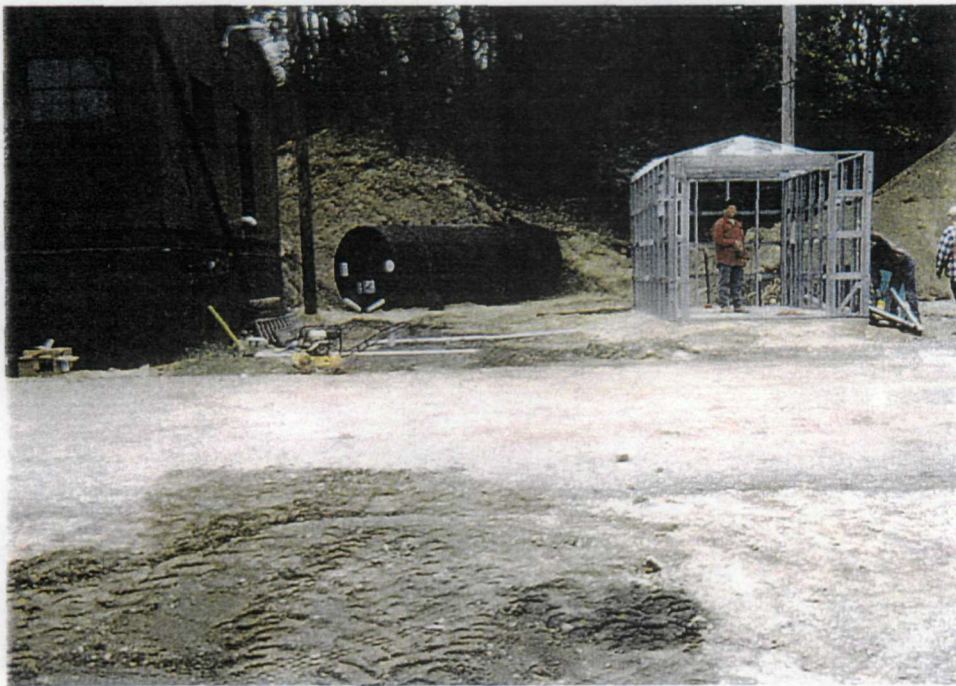
Photograph No. 19

Description: Installation of leachate collection tank and compressor and control building near maintenance area; electrical wiring also being installed

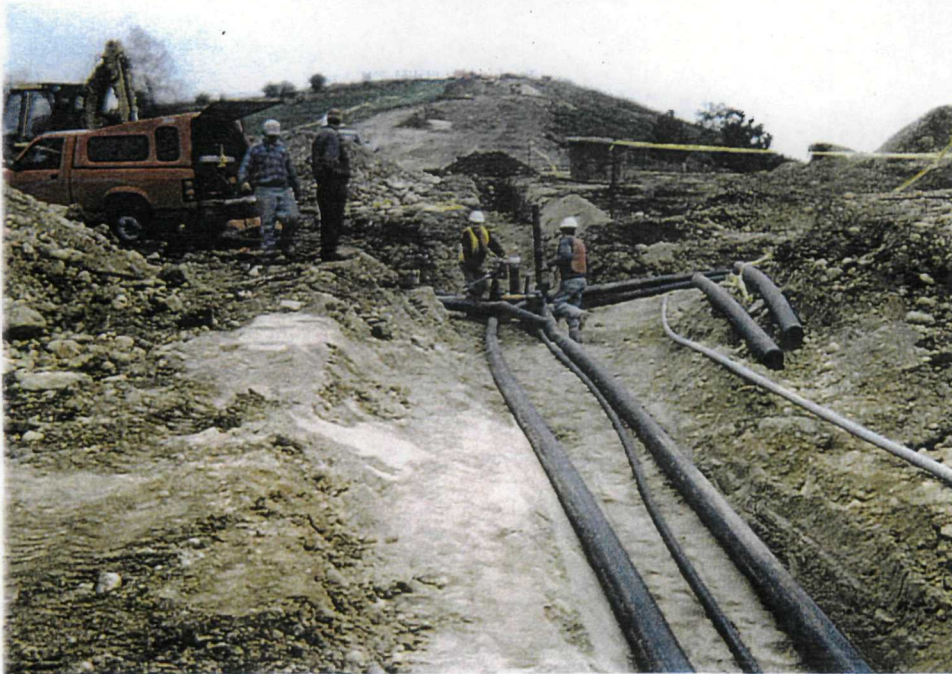
Photograph No. 20

Description: Installation of LCS trench and pipes at EW-01; pipes extending to right are connected to EW-01A; pipes extending to left are connected to EW-03

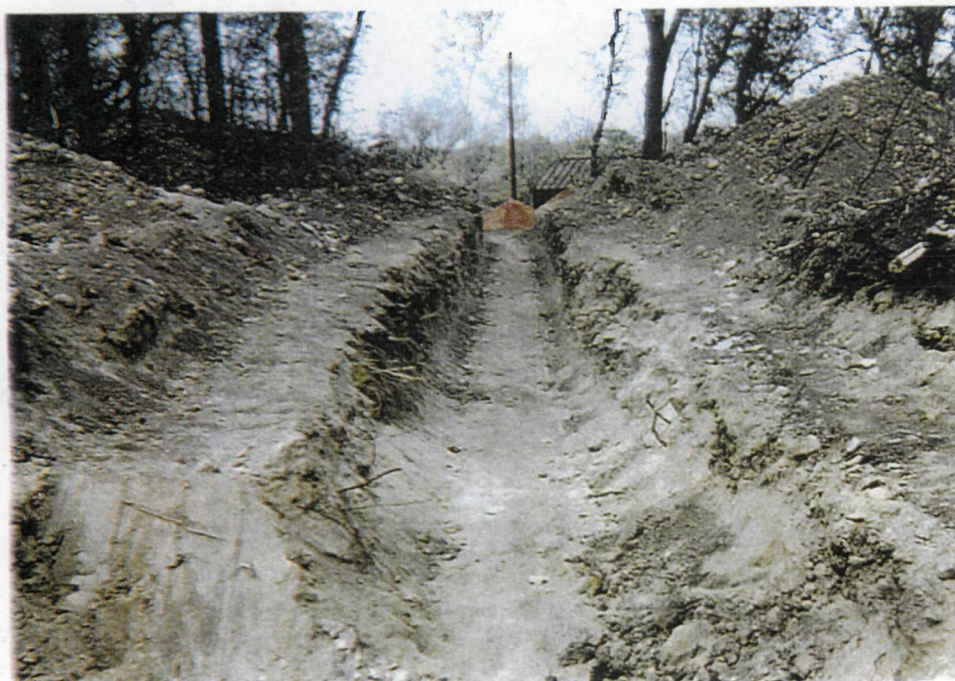
Photograph No. 1*

Description: LCS trench excavated through wooded area on north side of landfill

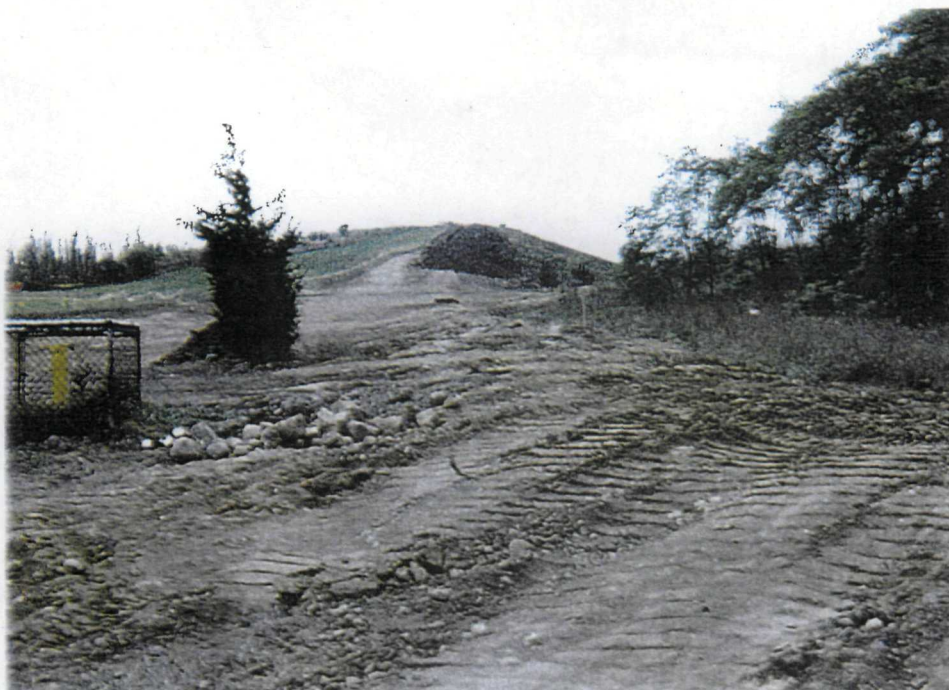
Photograph No. 4

Description: LCS trench on north side of landfill after it had been backfilled with clay; portion of trench near top of the landfill had also been covered with topsoil from stockpile on north side of Area 3

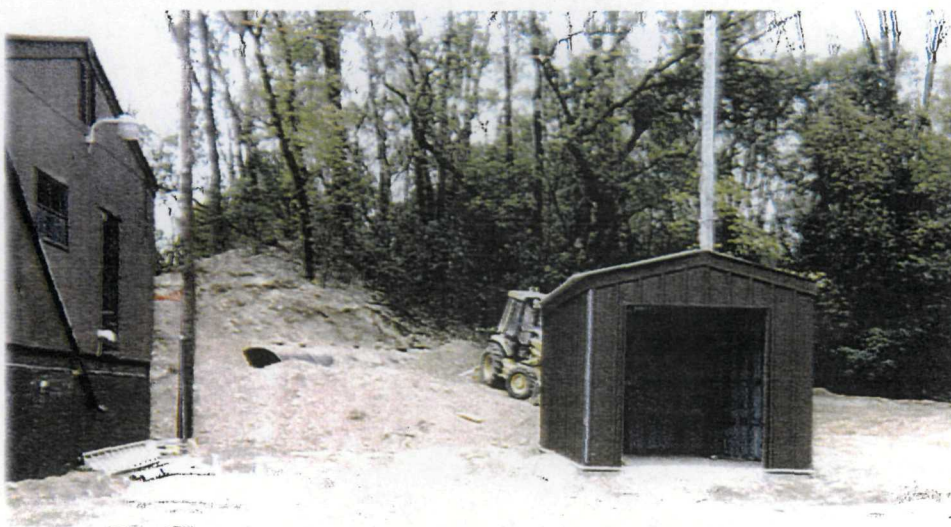
Photograph No. 5

Description: Leachate collection tank after it had been partially covered; siding had been placed on compressor and control building on right

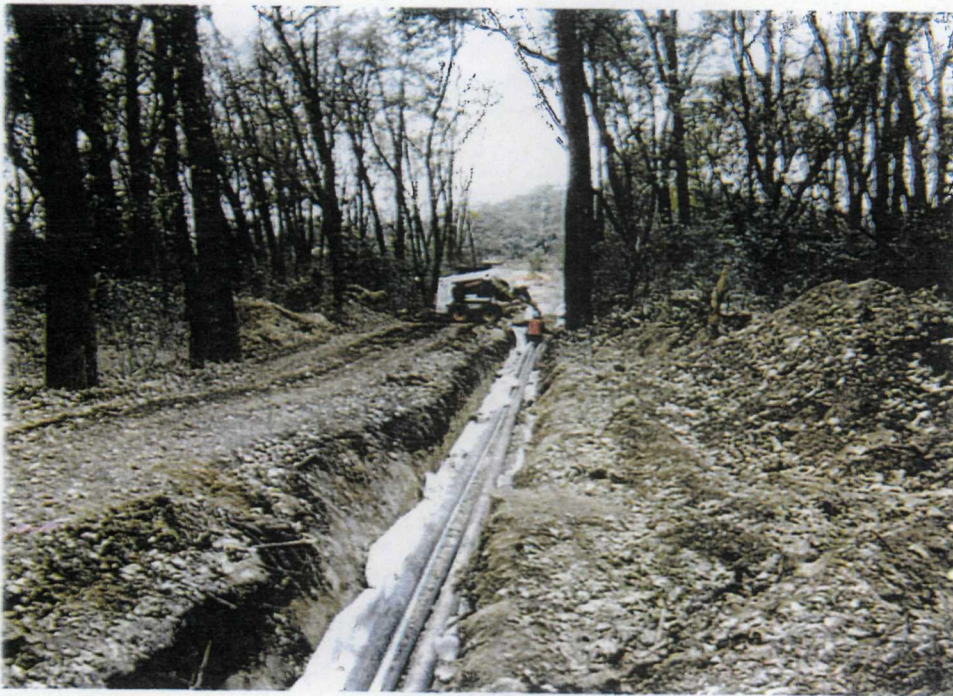
Description: LCS trench up to point where it entered wooded area; ground surface had been built up to provide sufficient frost protection; connections to MH-3 (orange fence) had also been made

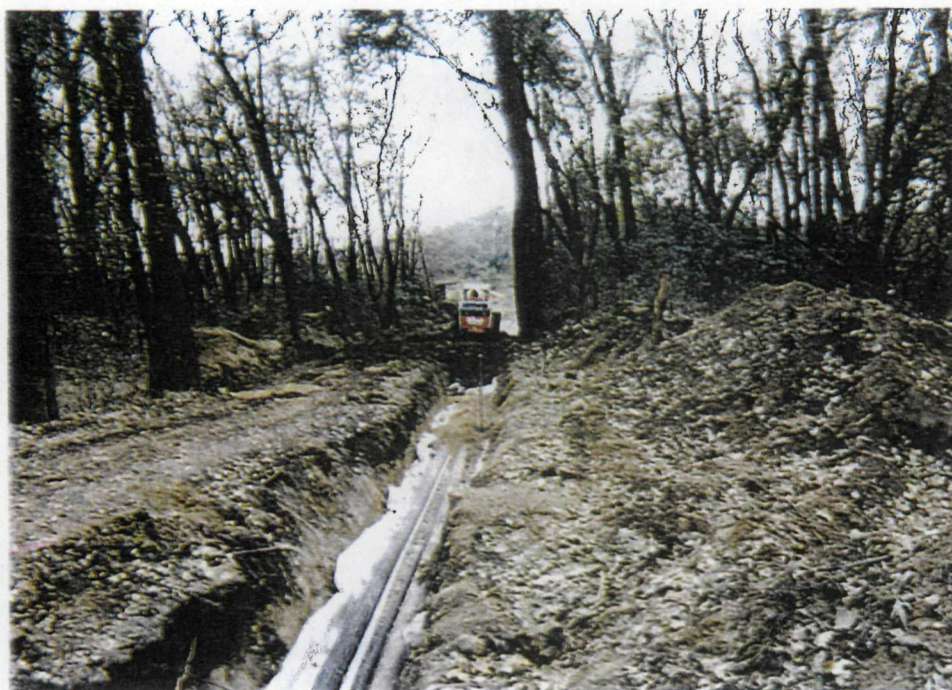
Description: Close-up of LCS trench and GCL after trench had been backfilled with sand, sides of GCL had been folded over, and additional layer of GCL had been placed on top

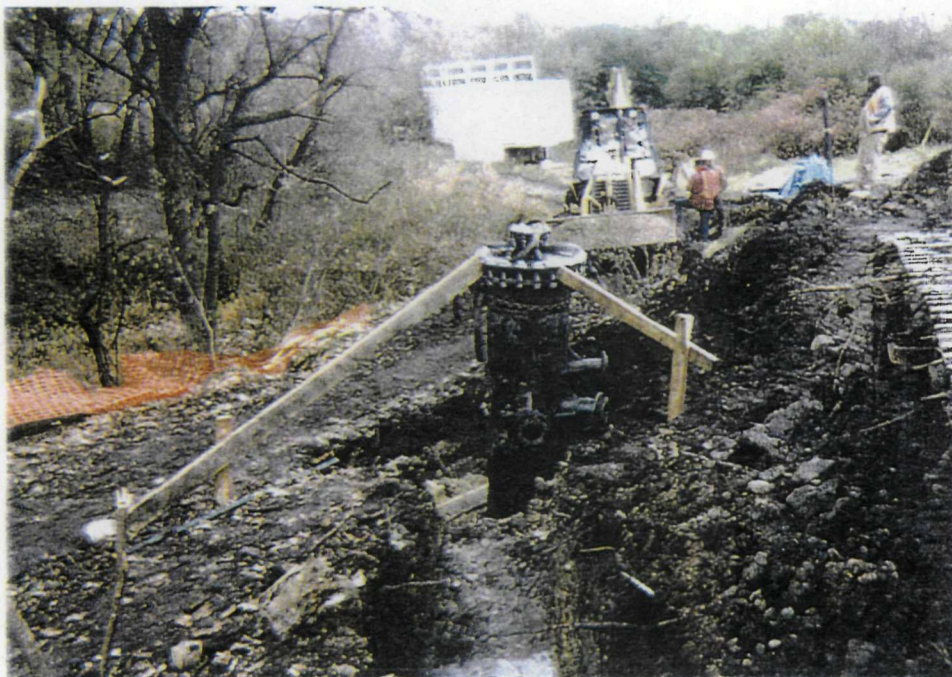
Description: View of water in MH-20 near DL-01 excavation; a plug had been placed in white pipe in MH-20 to cutoff water flowing into it

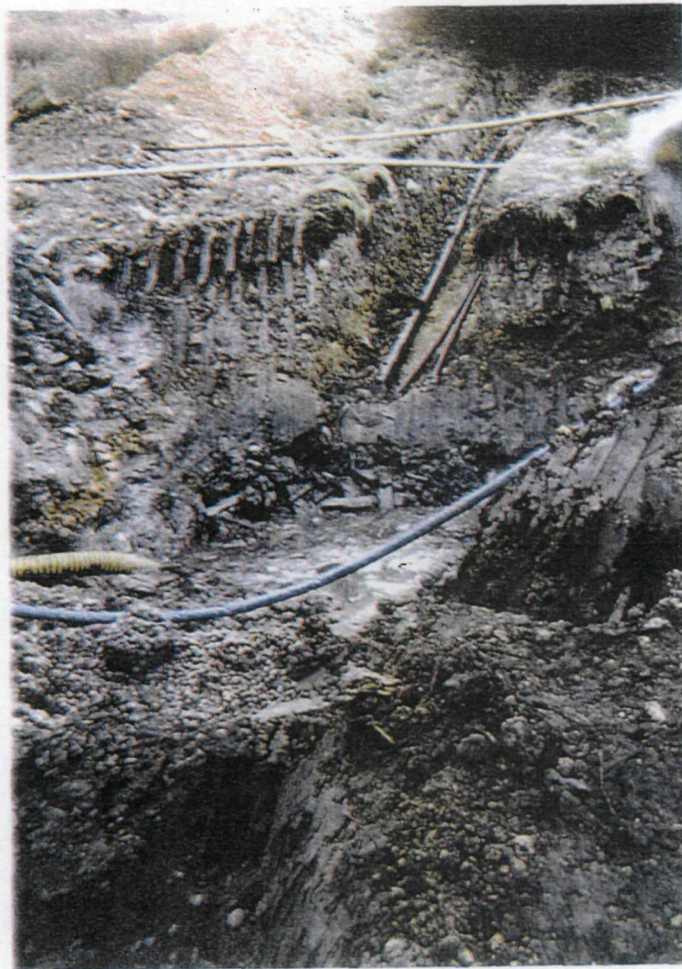
Description: MH-20 after most of the water in it had been pumped out; white pipe in MH-20 had been cut and removed; ends of pipe had been plugged; however, pipe to left was leaking around outside of pipe

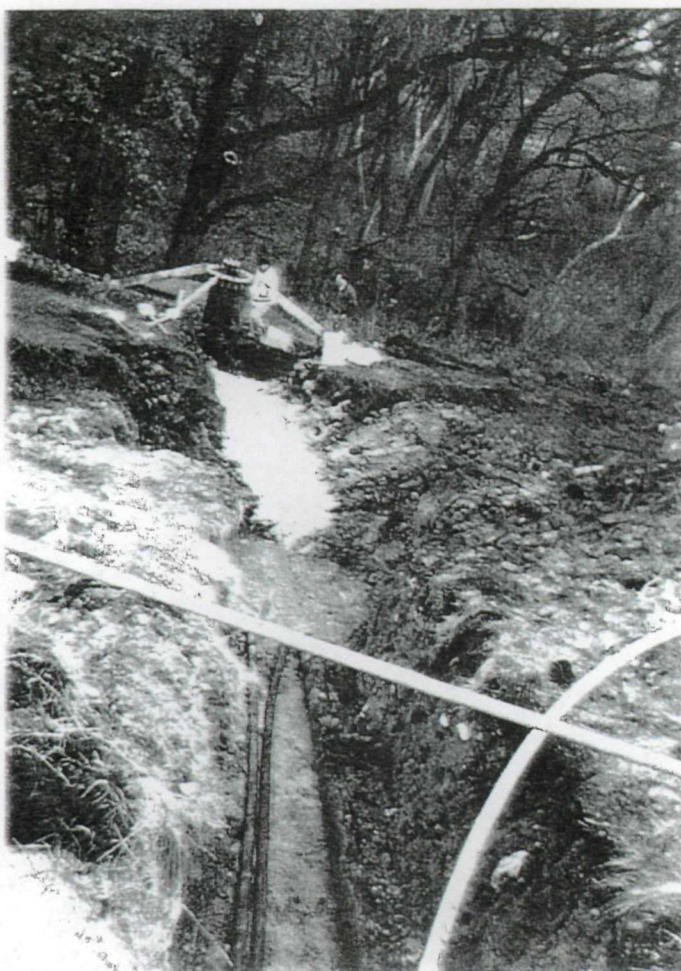
Description: Overview of DL-01 excavation activities; waste removed from excavation on right; pump and white hose used to remove water from excavation in front of excavator; lift station (black pipe) on left
